The Results of the T-45 Main Landing Gear Uplock Investigation and the Effect that Organization Structure Had on Them

Christina Marie Stack

A Thesis
Presented for the
Master of Science Degree
The University of Tennessee, Knoxville

Christina Marie Stack
August 2004

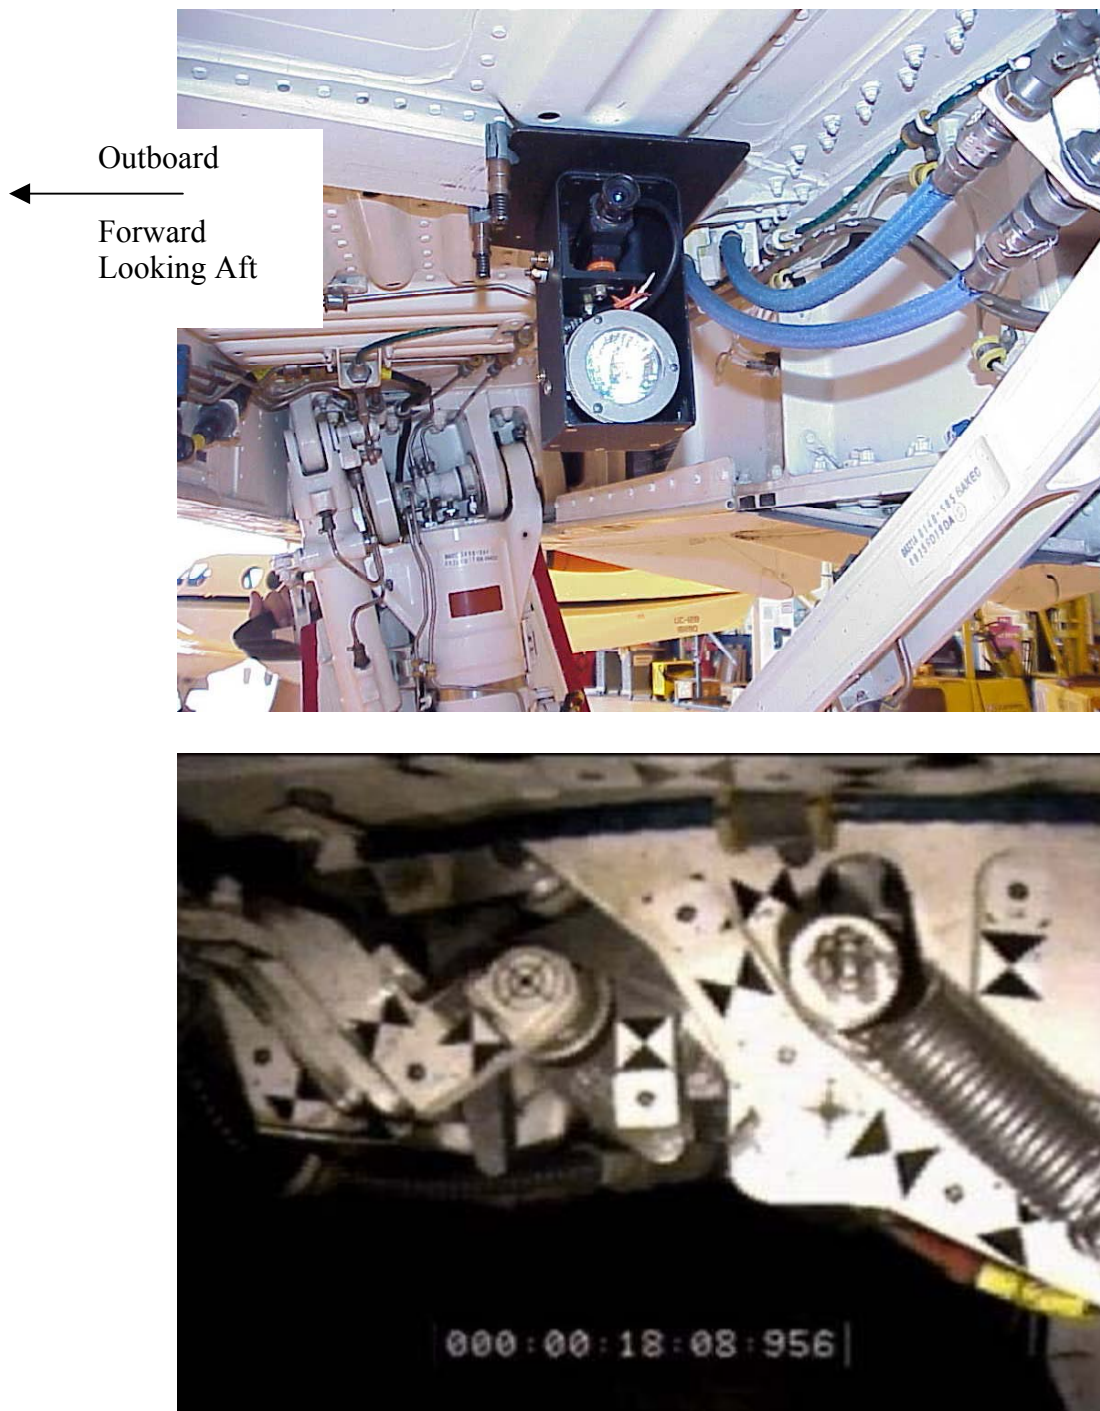
Figure 9: LEFT MLG CAMERA INSTALLATION (TOP)
AND UPLOCK VIEW FROM CAMERA (BOTTOM)

A 30-frame/second camera and light source were mounted in each MLG wheel well in order to monitor the roller and latch motion, Figure 9, Appendix A. The video was monitored real time to ensure that the gear was up and locked.

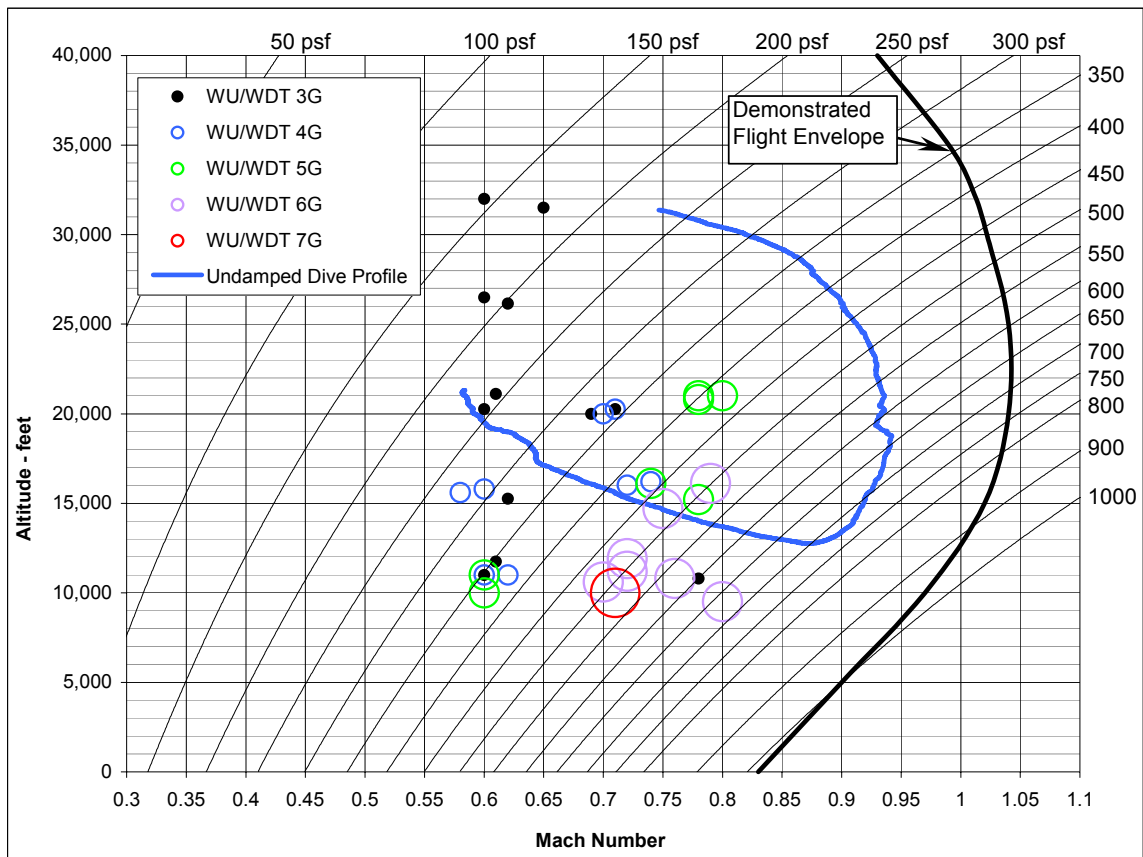
Figure 19: UNDAMPED MAIN LANDING GEAR COMPLETED TEST POINTS

performed with the hydraulics depressurized (undamped latch/ roller contact) to ensure that the gear door would not open if the roller fell past the latch during the maneuvers (Appendix B). The remainder of the WUTs were completed with normal hydraulic pressure (damped latch/roller contact). A final set of test points was completed with the hydraulics depressurized (undamped) with the thicker diameter spring pin installed in the right side of the aircraft. On the first attempt to complete the 7g WUT with the pitch buck phenomena and the placement of the instrumentation, the aircraft achieved 7.8g for less than a second, which exceeded the 7.33 g limit. In order to prevent any future g exceedences, the remainder of the 7 g WUTs were completed with a 6.5g target. A plot of the WUTs that were completed in the undamped and damped configurations is presented in Figures 19 and 20 (Appendix A), respectively.

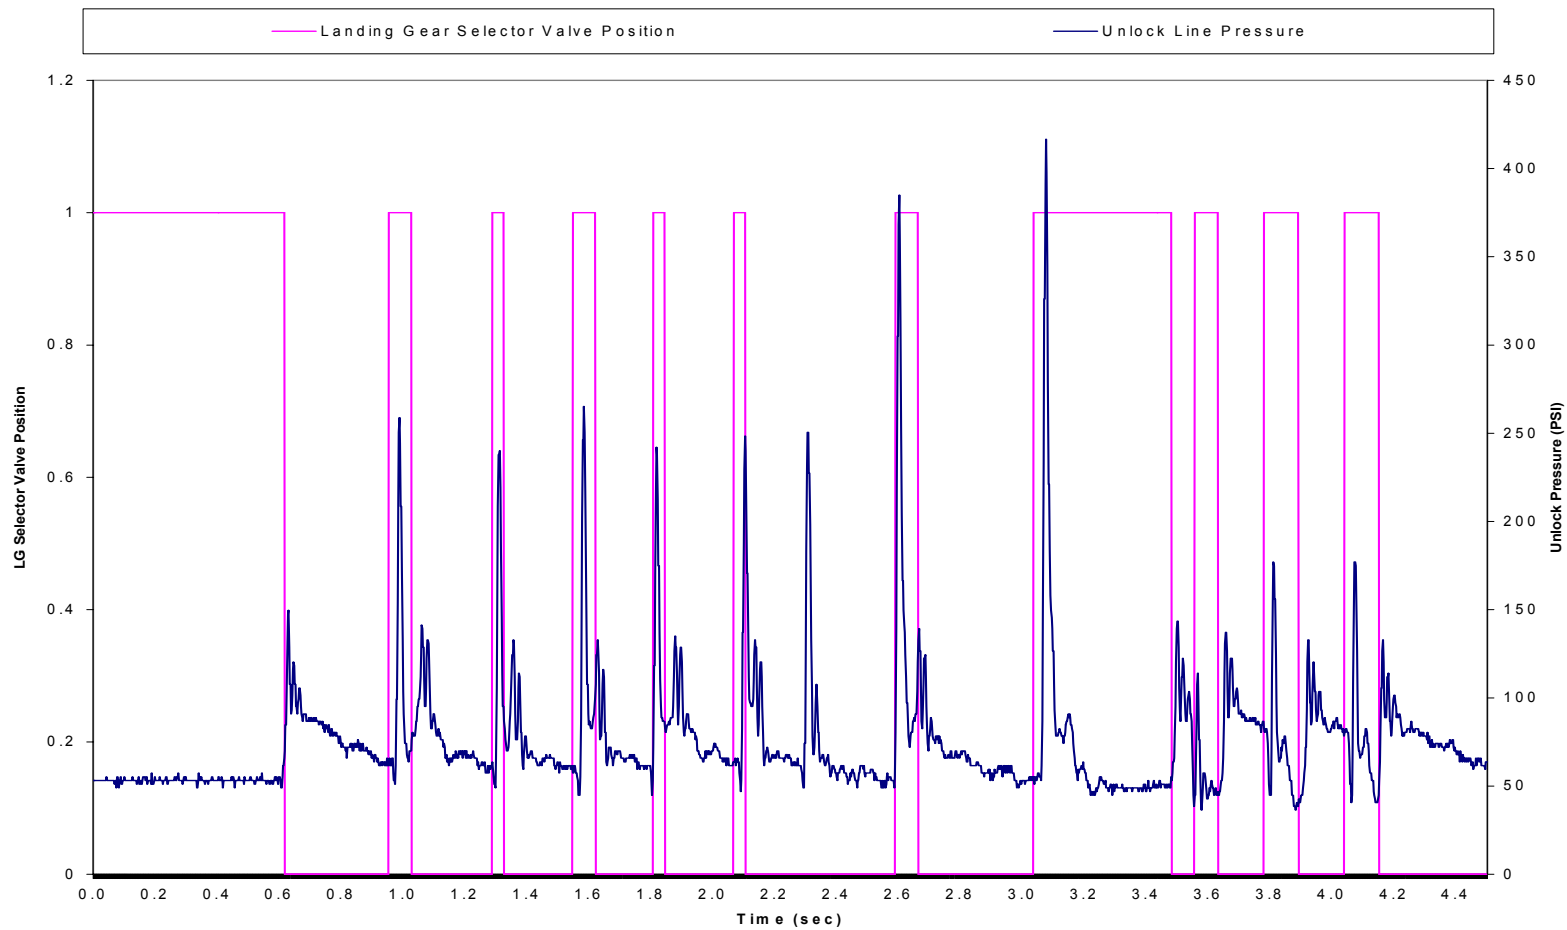
Figure 23: UNLOCK PRESSURE DURING TEST POINT 4-6, SWITCH TOGGLED TO DISABLED POSITION
(Note: Position 1: Gear Retracted, Position 0: Gear Extended)

At the completion of the WUT phase of testing, there had been no obvious problems identified. At all of the high g points there was no obvious movement of the system. The team then investigated the hydraulic pressure. The hope was that the pressure changes, as seen in Figure 23 (Appendix A), might lead to the ultimate causal factor. Unfortunately, the results were inconclusive and the team was left without an obvious answer. The flight test team, using the experience and results of the tests that had been completed, requested a new flight clearance that would allow the original configuration to be flown. The flight test community felt that it was their responsibility to find an answer, even if
